MacAskill Brook Dam Reservoir Source Water Protection Plan

CBRM Water Utility
2014

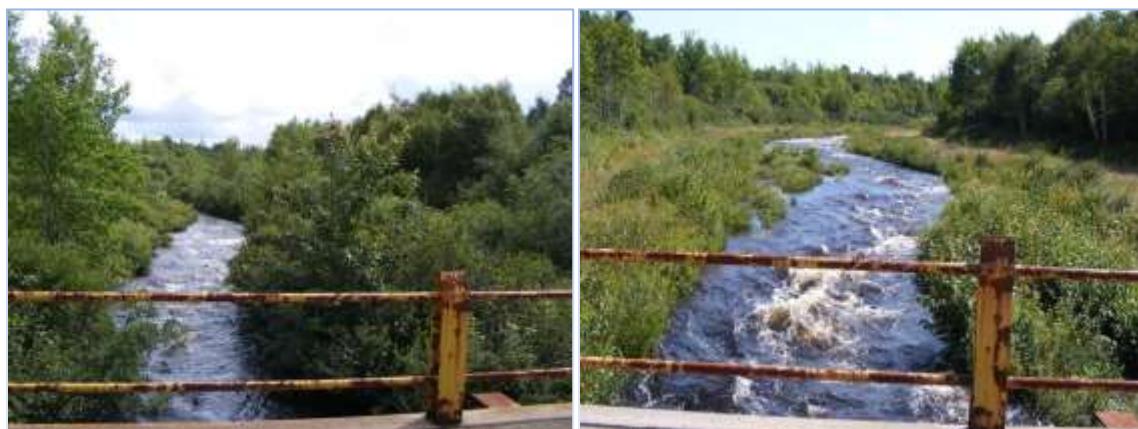
The cursory inspection by the NSPI engineer identified several issues requiring immediate attention: spillway channel vegetation to be removed; driftwood to be removed from the spillway; vegetation on the crest, face, and toes of the dam to be removed; missing rip rap to be replaced; and the steel checker plate in the gate house to be replaced with open grating.

In the summer of 2010 a local contractor removed all the vegetation from the spillway channel and the top, face, and toe of the dam. Figure 3 shows before and after photographs of the spillway channel, which now has significantly more discharge capacity during significant flood events.

Figure 3. Spillway channel September 2008 on left and September 2012 on right

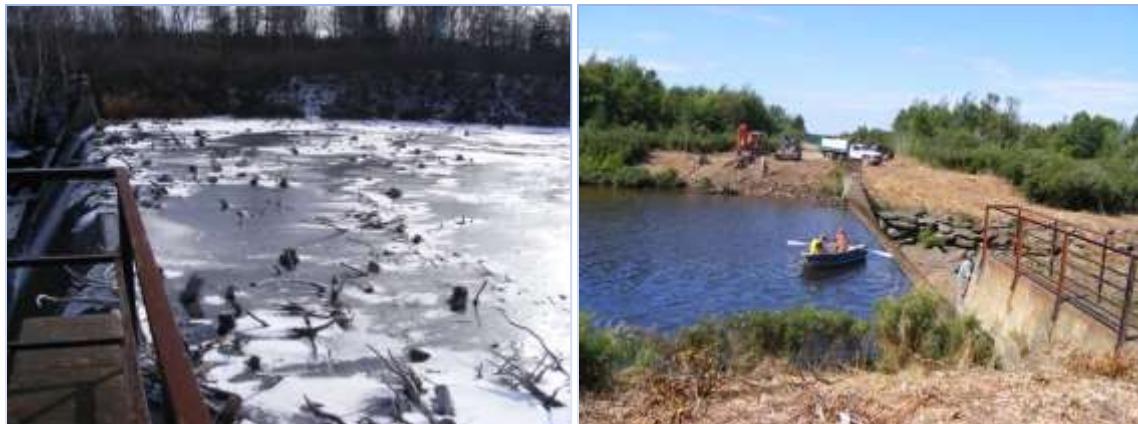
During flood conditions, stumps behind the spillway can accumulate additional debris and significantly reduce the discharge capacity of the spillway. Figure 4 shows the contractor completing the removal of the stumps from the spillway in September 2010.

Figure 4. Stumps blocking spillway January 2010 and being removed September 2010

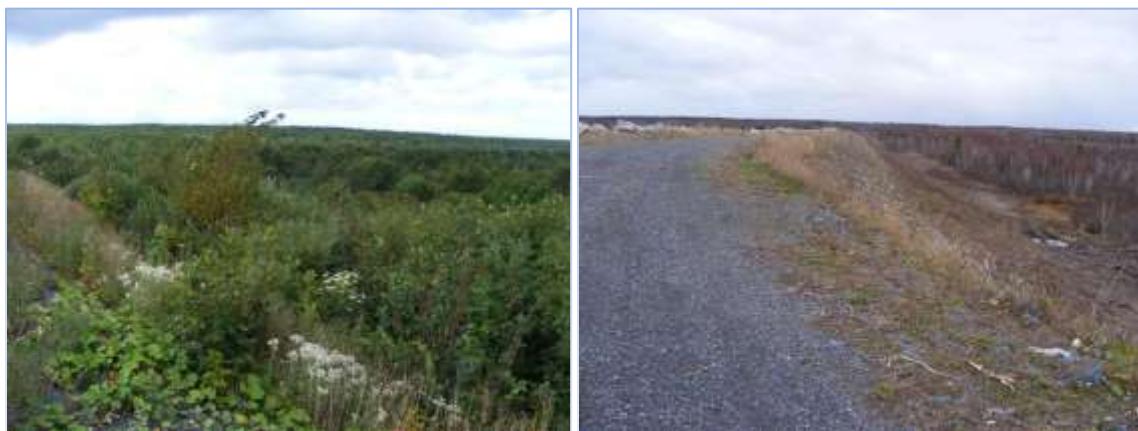
Vegetation on dams should be removed because roots can penetrate and loosen soils, as well as create voids when the plants die and the roots decay. The presence of vegetation also makes a proper inspection of the dam difficult or impossible. As such, any early warning signs of problems with the dam (such as sinkholes or significant leakage) could be missed during routine inspections. Figure 5 shows the dam face before and after vegetation removal and Figure 6 displays the difference in the view of the top of the dam from the spillway following brush removal.

Figure 5. Dam face September 2008 on left and November 2010 on the right

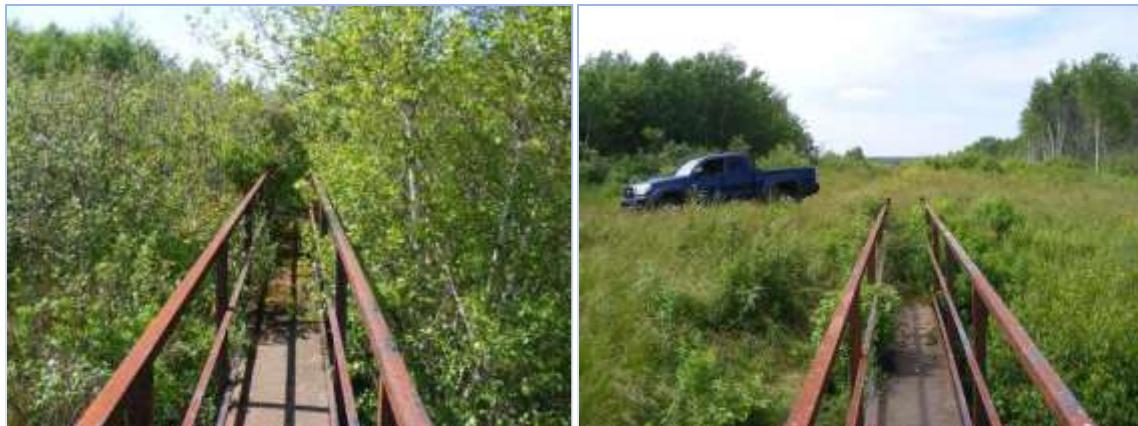
Figure 6. Top of dam from spillway June 2009 on left and July 2013 on right

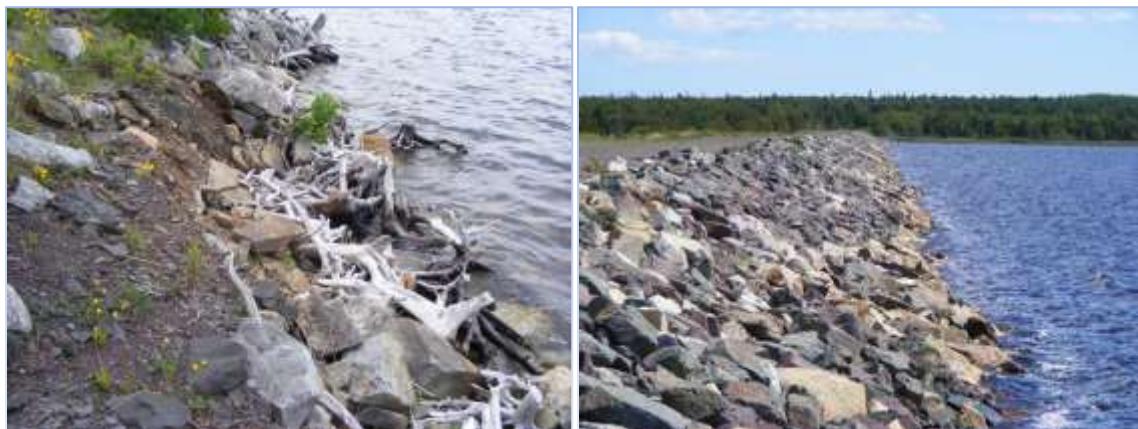
The NSPI review determined that the condition of the rip rap on the upstream slope of the dam varied from “poor” in those areas exposed to significant wave action, to “good” in those areas which are more sheltered from wave action. The variability of the type, shape and size of rip rap along the length of the dam indicated it had been repaired locally on previous occasions. In the area of greatest fetch (longest wind distance over open water), the rip rap was almost completely missing, as shown on the left in Figure 7. Since the riprap protects the upstream slope of the dam from wave action, this dangerous condition increases the likelihood of wave-induced erosion and a resulting overtopping failure.

Figure 7. Missing rip rap June 2009 and same section following repair August 2011

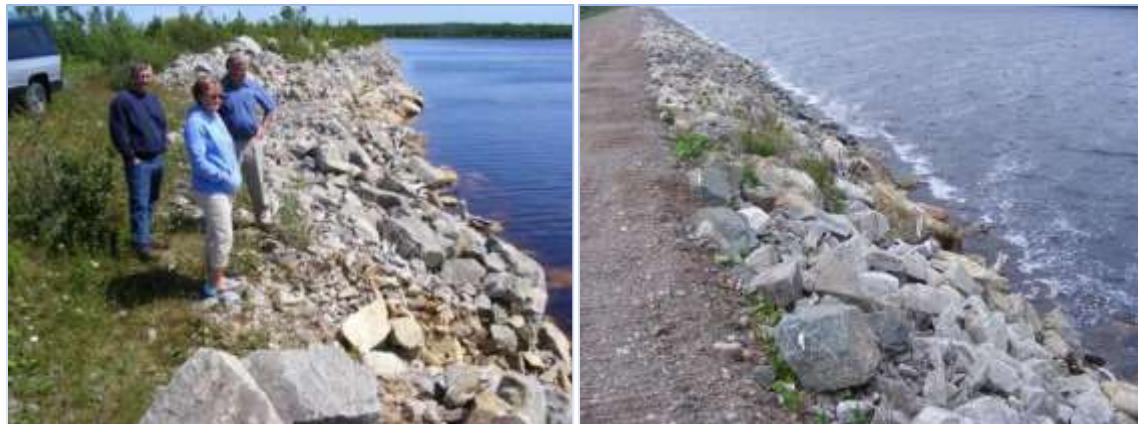
Along the length of the dam, there were localized areas of rip rap displacement. Near the abutments, the original rip rap was almost completely disintegrated. In the vicinity of the intake structure, the rip rap was displaced and appeared undersized for the application. In addition, the rip rap did not appear to extend high enough, as evidenced by driftwood located well above the rip rap. As a result of the NSPI review, CBRM contracted an engineering firm to assess the design of the rip rap and its bedding material along the entire length of the dam and prepare a plan for emergency remediation. A local contractor was then hired to replace or repair bedding and/or rip rap as required. Figure 8 shows an area near the gate house before and after the repairs.

Figure 8. Before and after rip rap repairs July 2009 and July 2011

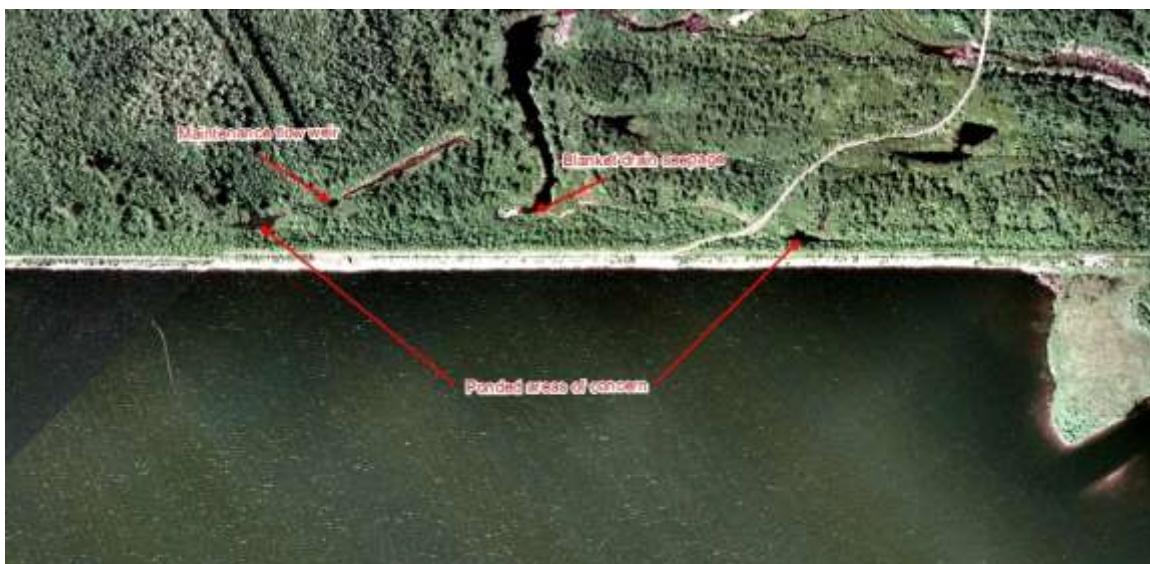
Since 2008 consultants have expressed concern about the surface standing water at several locations on the downstream toe of the MacAskill Dam. Exp recommended draining the surface water and grading to existing drainage features. The toe of the dam needs to be dry to facilitate visual assessment of potential seepage flows. In late fall 2013, CBRM staff, an NSE Inspector specialist, and a local contractor visited the site of several ponds and developed a plan to remediate the ponds (see figure 9). Work is slated for spring 2014.

Figure 9. Ponded areas to be remediated

Minor seepage in the area of the blanket drain as shown in Figure 9 has been observed over the years and the blanket drain was repaired in 1993. Although exp says this seepage is not unexpected, they recommend collecting and measuring the volume of seepage flow at regular intervals. Tracking flow seasonally and with pond level will help establish anticipated flow levels. Unexpected changes in flow could be a warning sign of potential problems with the dam requiring further investigation (exp Services Inc. 2013b).

The MacAskill Brook Dam Safety Review confirmed that the dam was high enough to avoid overtopping in flood conditions, although another 30 centimeters of rip rap along the top would be beneficial for erosion control. Ponds at the toe of the dam make it impossible to determine if water is leaking under the dam. CBRM has obtained permission from NS Environment to remediate these former borrow pits and a contractor has been hired to do the work.

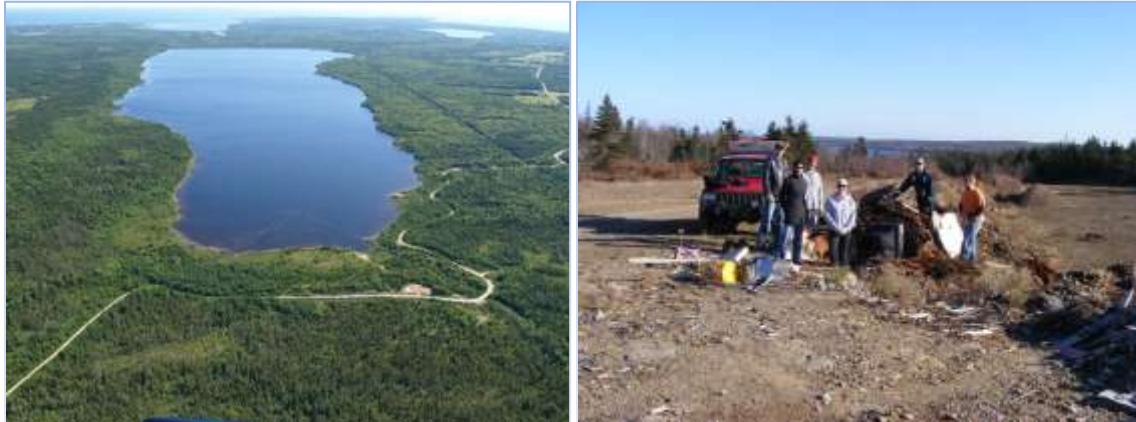
ADI Limited (2007) reported no NSEL permitted active or abandoned waste disposal sites within the MacAskill Brook watershed. However, Dillon (2004) listed illegal dumping as a potential source of watershed contamination and the old Cow Bay Road, seen in the foreground in the left hand image in Figure 11 is a popular dumping place.

Figure 11. Cow Bay Road and CBU cleanup crew with reservoir in the background

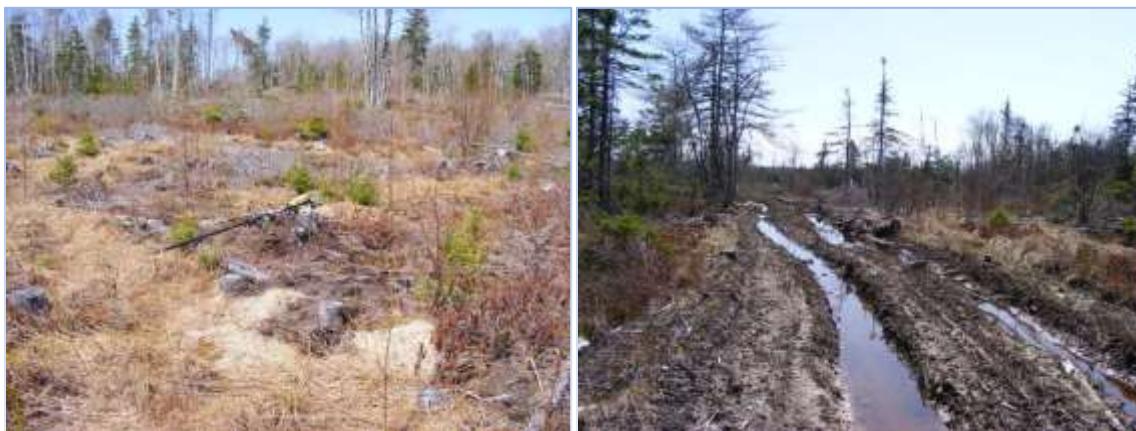
Forestry activity occurs on private land within the watershed, with clear cuts of various ages along the Old Cow Bay Road. As outlined in the May 2004 edition of Opflow (Ernst and others, 2004), increased forest cover in a watershed reduces the cost of treating drinking water. Forests, riparian areas, and wetlands act as natural filters, reducing the flow of pollutants to water bodies. Figure 12 shows a cut over on the upper reaches of MacAskill Brook and the skidder trail to take the wood closer to the Old Cow Bay Road.

Figure 12. Cut over near MacAskill Brook and skidder trail

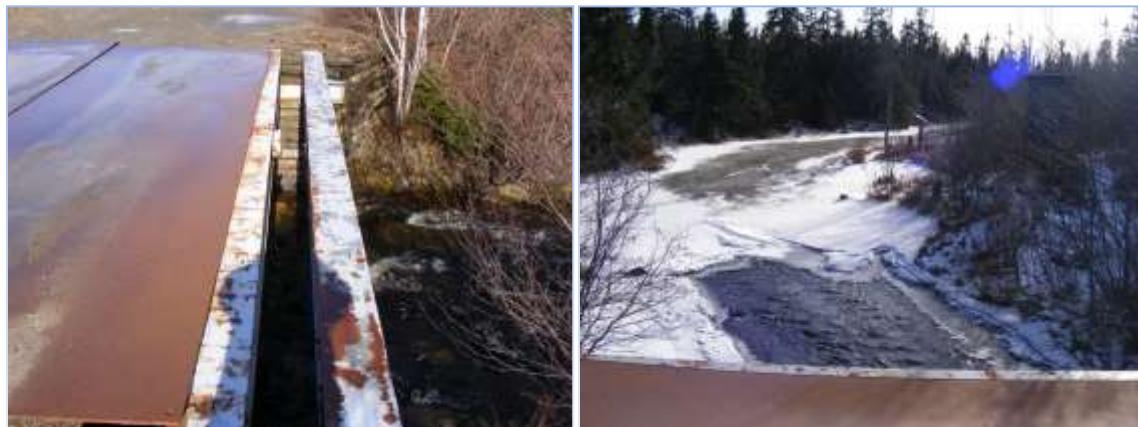
The Source Water Protection Committee first expressed concern in 2009 about the metal plate bridge on old Cow Bay Road crossing MacAskill Brook above the reservoir. CBRM sent an email to NSTIR expressing the fear that without guard rails or even curb stops, there was considerable risk of a vehicle sliding into the brook and contaminating the

water supply. There was no response from NSTIR and the committee asked again in 2013 that CBRM reiterate their concern to the Province, who owns old Cow Bay Road. Following an accident on Thanksgiving weekend 2013, in which an ATV landed in the brook, CBRM Manager of Utilities Administration sent a letter to the District Director-Eastern of Nova Scotia Department of Transportation and Infrastructure Renewal asking for road upgrades. Figure 13 shows the somewhat icy bridge used by logging trucks and the lack of a curb stop to prevent vehicles sliding into MacAskill Brook.

Figure 13. Bridge over MacAskill Brook on old Cow Bay Road

over MacAskill brook requires a curb or guard rail and TIR staff have been told of this deficiency.

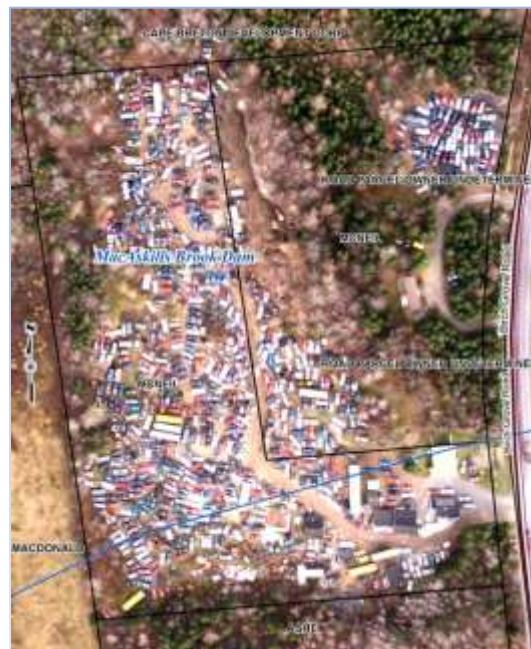
At a Source Water Protection Committee meeting in June 2009, members expressed concern about the salvage yard in Birch Grove as it is adjacent to a brook flowing to the reservoir. Figure 14 shows the large number of vehicles on site in 2008.

Figure 14. Birch Grove salvage yard as seen in 2008 photography
